Brookdale Assessment Centre

Grassland Rehabilitation Plan

ERF 1061 and 1068 Brookdale Phoenix, Durban
1143 JG Champion Drive, Phoenix, Ethekewini Municipality, Kwazulu-Natal

January 2022

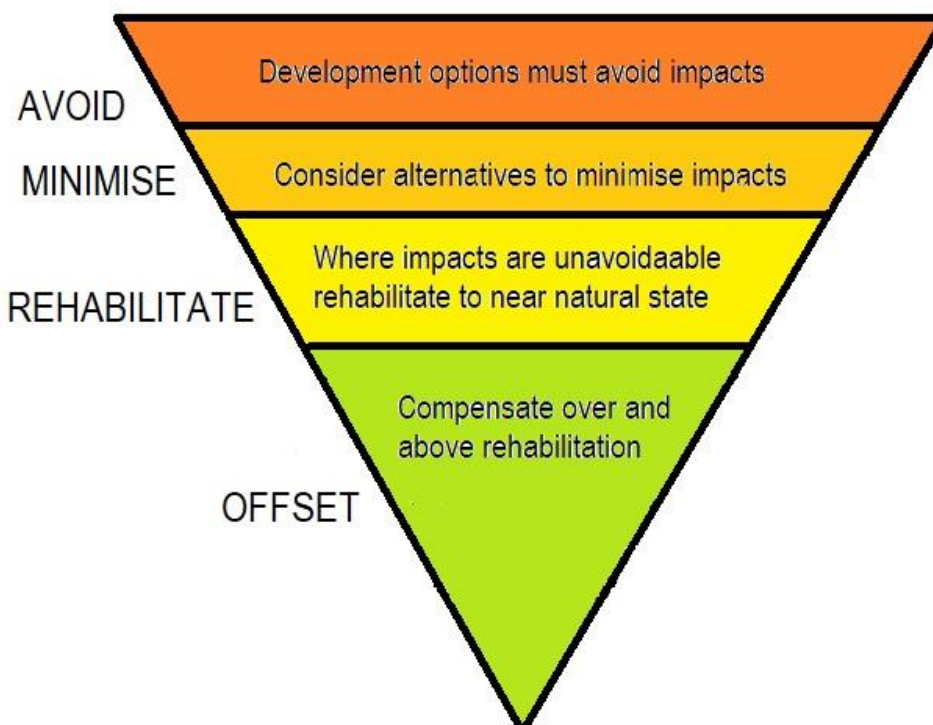
Figure 2 The Mitigation hierarchy summarised graphically

Negative impacts on sensitive ecosystems must be mitigated as it is a legal requirement. Whenever an activity takes place and it has impacts then steps need to be taken to minimise the impacts with each level being less desirable until the last level which will require the highest level of investment to mitigate the activity that has the biggest impact. Illustrates as follows;

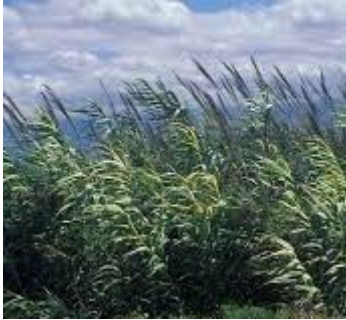
Species Name	CARA/NEMBA Category	Photo	Control Recommendations	
			Size	Treatment
<i>Arundo donax</i> (Spanish Reed)	1b

All	Mechanical removal
<i>Parthenium hysterophorus</i> (Famine Weed)	1b

Invasive alien plants that EcoPulse did not pick up on is *Arundo donax*, the Spanish Reed, and *Parthenium hysterophorus*, the Famine Weed.

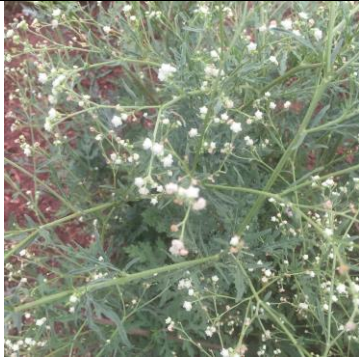
All	Removal by hand. Gloves are recommended to prevent skin contact

The grassland must be maintained free of invasive alien plants with specific focus on the Famine Weed. A mature plant produces as many as 10 000 seeds in a season. The seed germinate readily which attaches itself to shoes, tyres, wheels, hooves and is dispersed aiding its rapid spread. The plant is resistant to herbicide and cause injury to staff if they are exposed to the plant for a long period causing serious illness.
